# Manhole Inspection Summary

Manhole # S49A\_\_020MH

Insp Date: **6/10/08 1:11 PM**

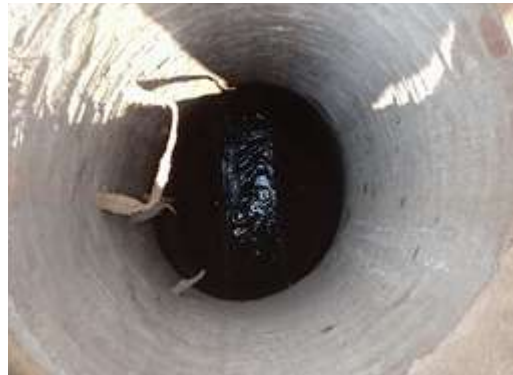
Top View

**Frame** Offset: **2** (in.) Condition: ☐ Sound ☐ Cracked ☒ **Leaks**

Infiltration: ☐ None ☒ **Joint** ☐ Cracks ☐ Mortar ☐ Roots ☐ Wall
